INDOOR AIR QUALITY ASSESSMENT

James F. Peebles Elementary School 70 Trowbridge Road Bourne, Massachusetts

Prepared by:
Massachusetts Department of Public Health
Center for Environmental Health
Bureau of Environmental Health Assessment
Emergency Response/Indoor Air Quality Program
June 2004

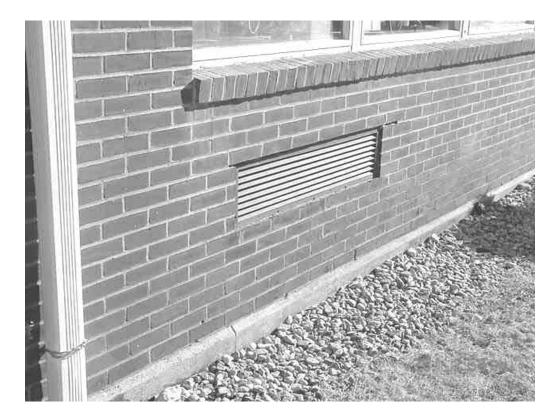
Fresh air in classrooms is supplied by a unit ventilator (univent) system. Univents are designed to draw air from outdoors through a fresh air intake located on the exterior walls of the building (Picture 1) and return air through an air intake located at the base of each unit (Figure 1). Fresh and return air are mixed, filtered, heated and provided to classrooms through a fresh air diffuser located in the top of the unit. Univents were reported to be original equipment (approximately 50 years old), which can make them difficult to maintain/function due to unavailability of parts. Univents were deactivated in a number of areas throughout the building, preventing a continuous source of fresh air. Obstructions to airflow, such as papers and books stored on univents and bookcases, carts and desks in front of univent returns, were also seen (Pictures 2 and 3). In order for univents to provide fresh air as designed, intakes must remain free of obstructions and importantly, these units must remain activated and allowed to operate while rooms are occupied.

Univent Fresh Air Intake

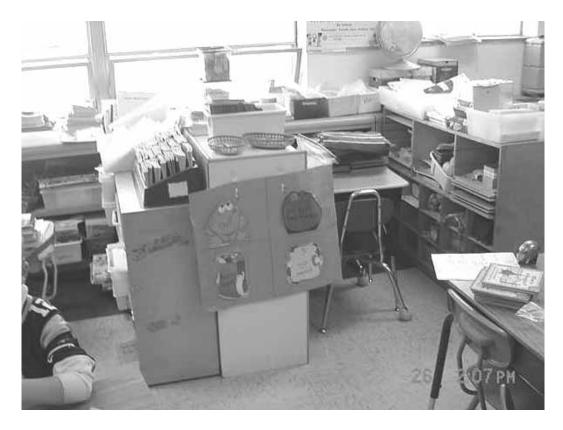
Classroom Univent Obstructed by Various Items

- 3. Inspect exhaust motors and belts for proper function. Repair and replace as necessary.
- 4. Remove all blockages from univents and exhaust vents to ensure adequate airflow.

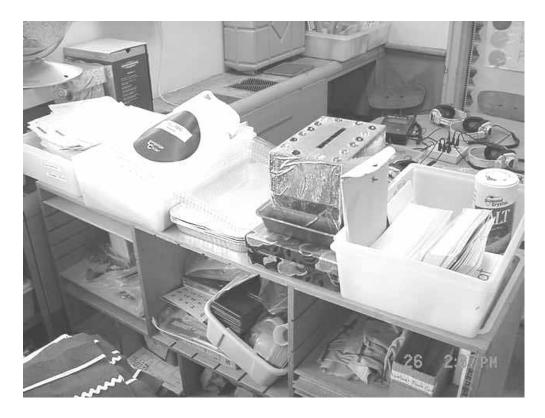
Univent Airflow Obstructed by Placement of Furniture

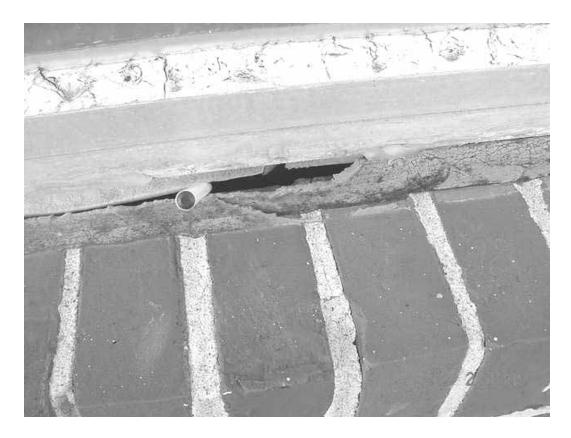
Caulking around windows was missing/damaged in many areas (Pictures 4 and 5). Water damaged wooden window frames and leaks were observed or reported in a number of classrooms. Some of the panes were loose or broken (Picture 6) and drafts were evident in several areas. Missing caulking and/or loose fitting window panes can make it difficult to control temperature and allow a means for water penetration into the building, leading to comfort complaints and/or water damage and subsequent microbial growth. A large crack in exterior brickwork to the rear of the building was also observed (Picture 7). Breaches in the building envelope can also provide a means for water penetration into the building. The US Environmental Protection Agency (US EPA) and the American Conference of Governmental Industrial Hygienists (ACGIH) recommends that porous materials be dried with fans and heating within 24 to 48 hours of becoming wet (US EPA, 2001; ACGIH, 1989). If porous materials are not dried within this time frame, mold growth may occur. Water-damaged porous materials cannot be adequately cleaned to remove mold growth. The application of a mildewcide to moldy porous materials is not recommended.

Missing/Damaged Caulking around Exterior Window Frames

- 7. Seal window frames to prevent water penetration and further water damage.
- 8. Ensure roof leaks are repaired and repair/replace any remaining water-stained ceiling tiles. Examine the area above and around these areas for mold growth. Disinfect areas of water leaks with an appropriate antimicrobial.

- 1. Replace/repair window systems throughout the building-wide to prevent water penetration and drafts through window frames.
- 2. Based on the age, physical deterioration and availability of parts of the HVAC system, the BEHA strongly recommends that an HVAC engineering firm fully evaluate the ventilation system and its control system (e.g. pneumatic controls, air intake louvers, thermostats).

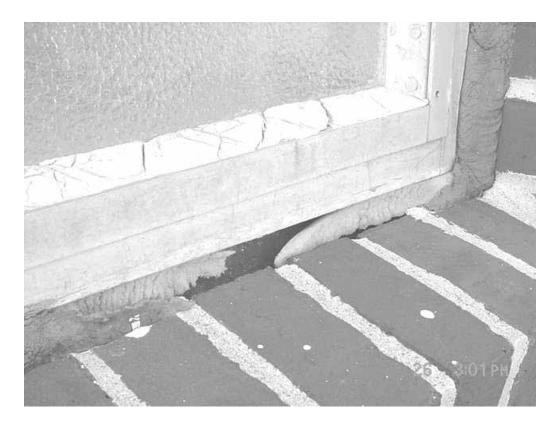
Missing/Damaged Caulking around Exterior Window Frames Exposing Insulation Material

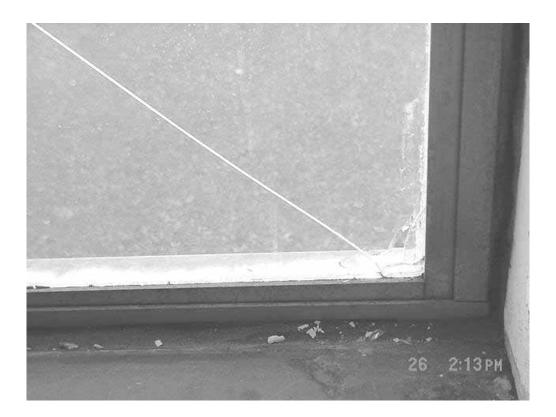
Broken Window Pane

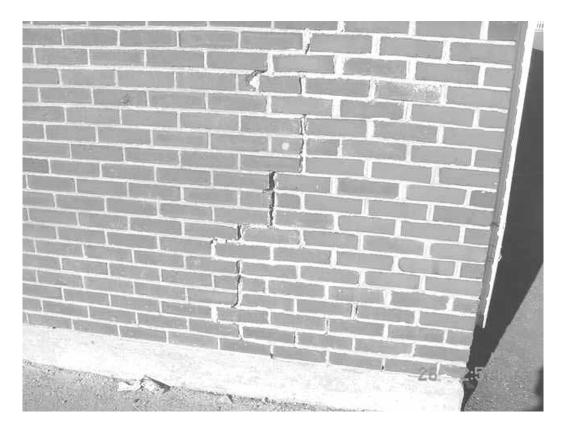
Large Crack in Exterior Brick (Rear Corner of Building)

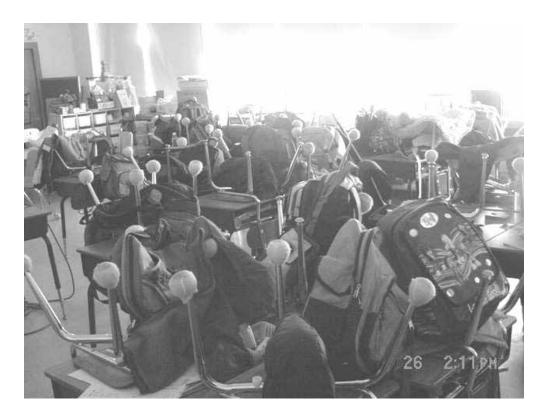
In an effort to reduce noise from sliding chairs, tennis balls had been sliced open and placed on chair legs (Picture 8). Tennis balls are made of a number of materials that are a source of respiratory irritants. Constant wearing of tennis balls can produce fibers and allow VOCs to off-gas. Tennis balls are made with a natural rubber latex bladder, which becomes abraded when used as a chair leg pad. Use of tennis balls in this manner may introduce latex dust into the school environment. Some individuals are highly allergic to latex (e.g., spina bifida patients) (SBAA, 2001). It is recommended that the use of materials containing latex be limited in buildings to reduce the likelihood of symptoms in sensitive individuals (NIOSH, 1997). A question and answer sheet concerning latex allergy is attached as Appendix B (NIOSH, 1998).

Tennis Balls on the Bottom of Chair Legs

- 13. Store cleaning products properly and out of reach of students. Ensure spray bottles are properly labeled in the event of an emergency.
- 14. Consider discontinuing the use of tennis balls on chairs to prevent latex dust generation.
